DRYZONE®

The world's most rigorously tested rising damp treatment

The Dryzone System is fast, clean and effective

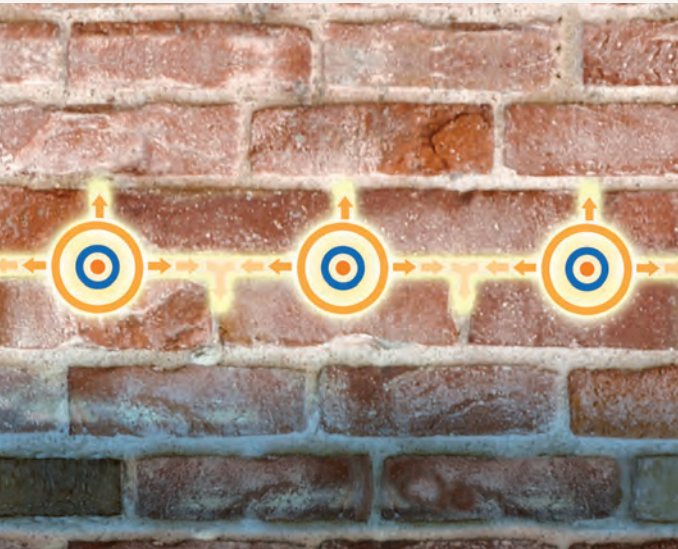
The introduction of the patented Dryzone damp-proofing cream has revolutionised the treatment of Rising Damp. The Dryzone cream is introduced by means of a simple applicator gun into a series of holes drilled into the mortar course. Once the Dryzone is installed, it diffuses to where it is most needed before curing to form a water-repellent resin.

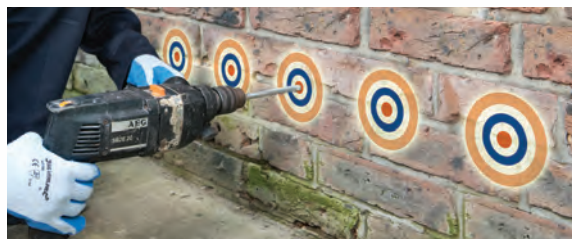
1. Drilling

First create a series of horizontal drill holes along the mortar course. Typically these are 12mm holes at 120mm spacings - refer to the Dryzone Application Instructions for details for particular wall thicknesses.

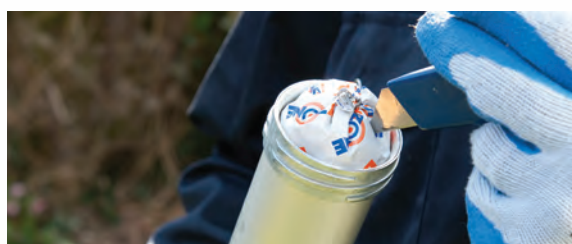
2. Preparation

Insert a Dryzone cartridge into the applicator gun, ensuring the pressure piston is fully extended. Cut into the end of the cartridge so that cream will be able to flow freely. Screw the nozzle cap back onto the gun.

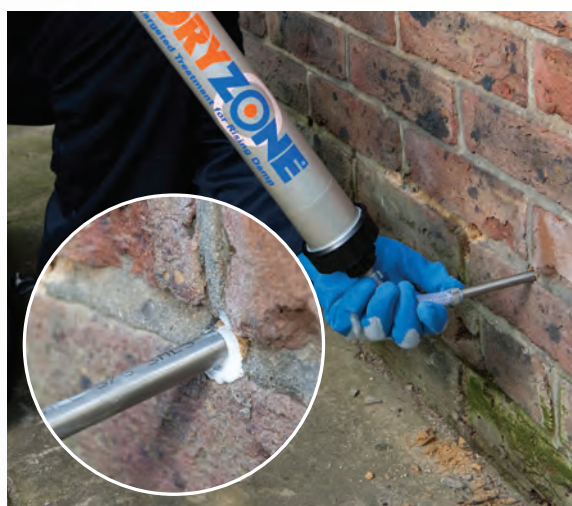
3. Injection

Fully insert the nozzle into the first drilled hole, and then inject Dryzone cream while withdrawing the nozzle at a steady rate. Stop injecting just before removing the nozzle from the wall. Repeat for remaining holes.
